Limited Asbestos Survey Report

Sun Chief Mill Site - Warehouse
Southeast Corner of Arizona Highway 77 & US 70
Globe, AZ

CSC Project # 5002357

Inspection Dates: January 26-27, 2010

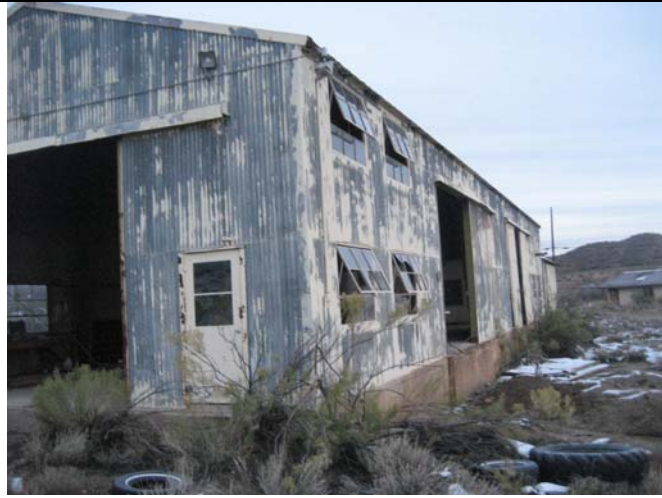
Photo 1: Warehouse – subject property south and east elevations

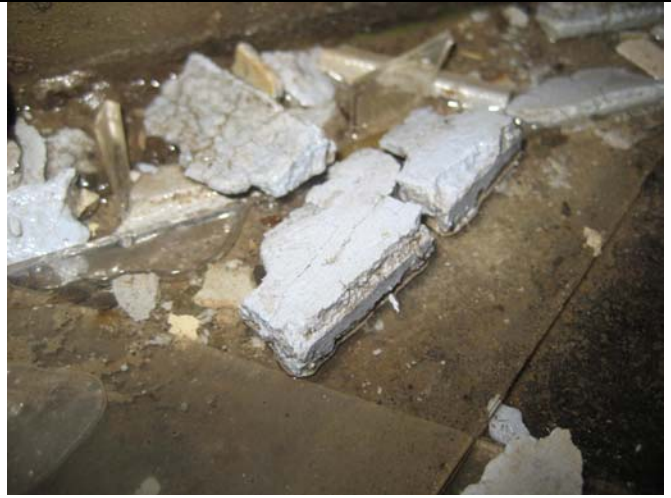
- **Off-white Window Putty**; < 0.25 % chrysotile asbestos via Point Counting
 - ~ 80 Square-feet
- **Black Roofing Mastic**; 9-12% chrysotile
 - ~ 40 Square-feet

Photo 2: Warehouse – example of off-white window putty

3. Removal of the off-white window putty containing < 0.25% Chrysotile throughout the subject property should be considered unclassified work; therefore, the EPA NESHAPS regulations are not applicable to the beige paint or materials containing beige paint. However, OSHA regulates demolition or repairs of the friable materials that contain less than 1% asbestos. According to OSHA, work conducted in areas where the asbestos or asbestos product is below one percent is "unclassified asbestos work". For such "unclassified work", the employer still must follow the requirements in the OSHA Occupational Exposure to Asbestos standard 29 CFR 1926.1101(g)(1)(ii) and (iii), as well as the record keeping requirements under 29 CFR 1926.1101(n). In brief the standards require:

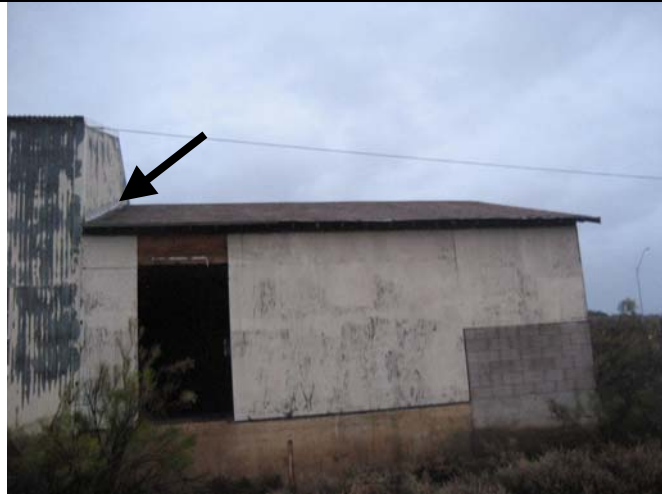
1. Exterior Black Roofing Mastic (~ 40 square feet) contained 9-12% chrysotile asbestos. The material is considered category II non-friable ACM.
 - a. The north side of the roof remained covered in snow at the time of the investigation. It is possible that roofing patches exist under the snow, thereby increasing the quantity of black roofing mastic.
2. The off-white window putty was found to contain asbestos fibers (<0.25% Chrysotile).
 - a. Point Counting is the considered more accurate than PLM when quantifying asbestos content as the PLM method is an estimation. Therefore, reported asbestos quantities are those detected via Point Counting.
3. Category of asbestos may change due to the means employed by the contractor to remove ACM.

Photo 3: Warehouse – black mastic positive for asbestos content occurs along the entire interface between lower roof and building (as indicated with the arrow) and around penetration points on other side of the roof

2. Removal of category II non-friable ACM (black roofing mastic) throughout the subject property should only be performed by certified asbestos abatement workers.

- a. Removal by hand means shall be considered class 2 work.
 - b. Removal by mechanical means shall render the asbestos RACM.
 - c. Workers performing said work should comply with all state, local and federal regulations.
